Case Studies

Using Caps to Limit NAPL Migration: Fox River (Wisconsin)

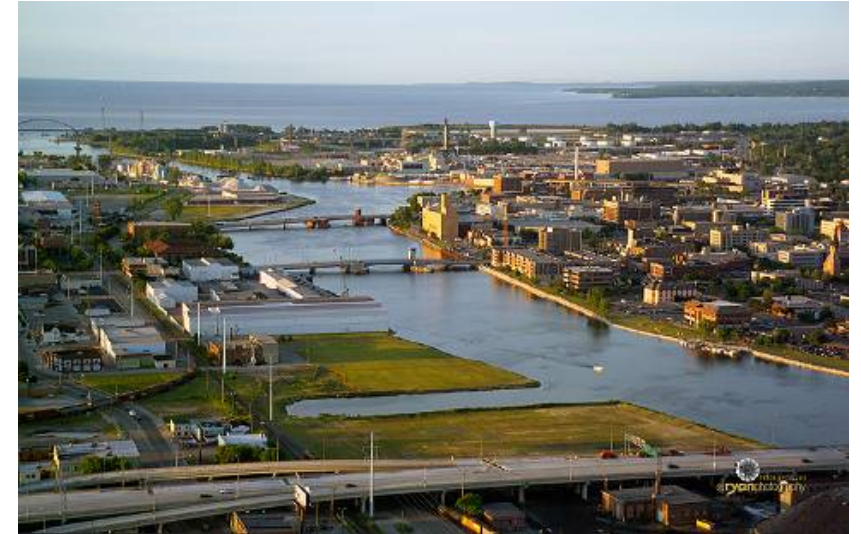
- 39-mile-long river and industrial waterway near Green Bay, WI with PCB-impacted sediment
 - Single largest contaminated sediment cleanup site in the United States
- Caps designed/installed at over 120 acres of the site
- Variety of erosive forces could impact the site, including large ships
- Cap incorporated organoclay for one portion of the site to address PAH-impacted sediment containing NAPL
- Latest Five Year Review (2019) indicates that the caps are performing as designed
- Monitoring of fish and water show significant reductions in PCB concentrations and are decreasing to meet the Remedial Action Objectives as intended in the Record of Decision

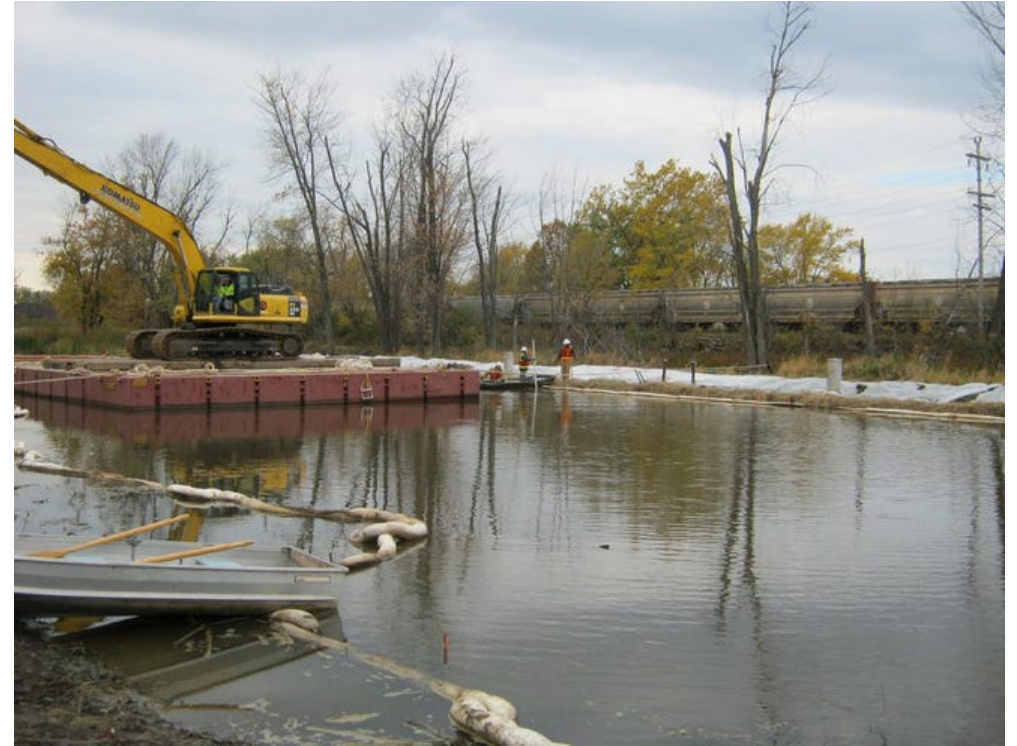
- 38-acre site in Burlington, VT consists of a canal and turning basin, adjacent wetlands, a pond, and land
- 2004 remedy included capping with sand over 8 acres of contaminated sediments
 - Initial cap design did not include an amendment to control NAPL
- Post-construction monitoring identified ongoing release of coal tar in a limited area of the canal
- An amended cap was constructed in 2010 to address releases of oily sheen and coal tar found during monitoring, which included organoclay to address NAPL
- Latest Five Year Review (2021) concluded that the cap remains in place and is functioning as designed

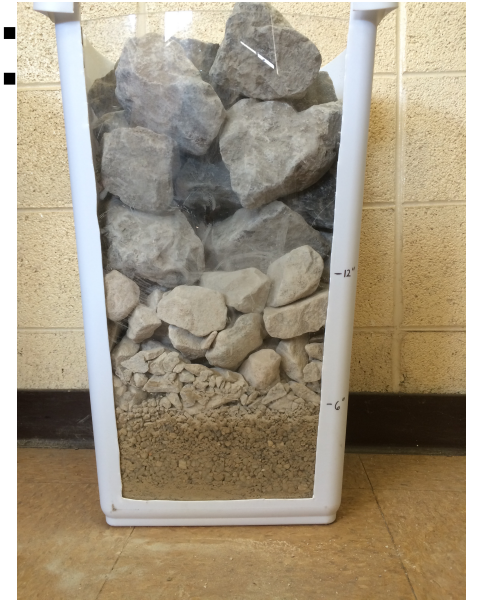
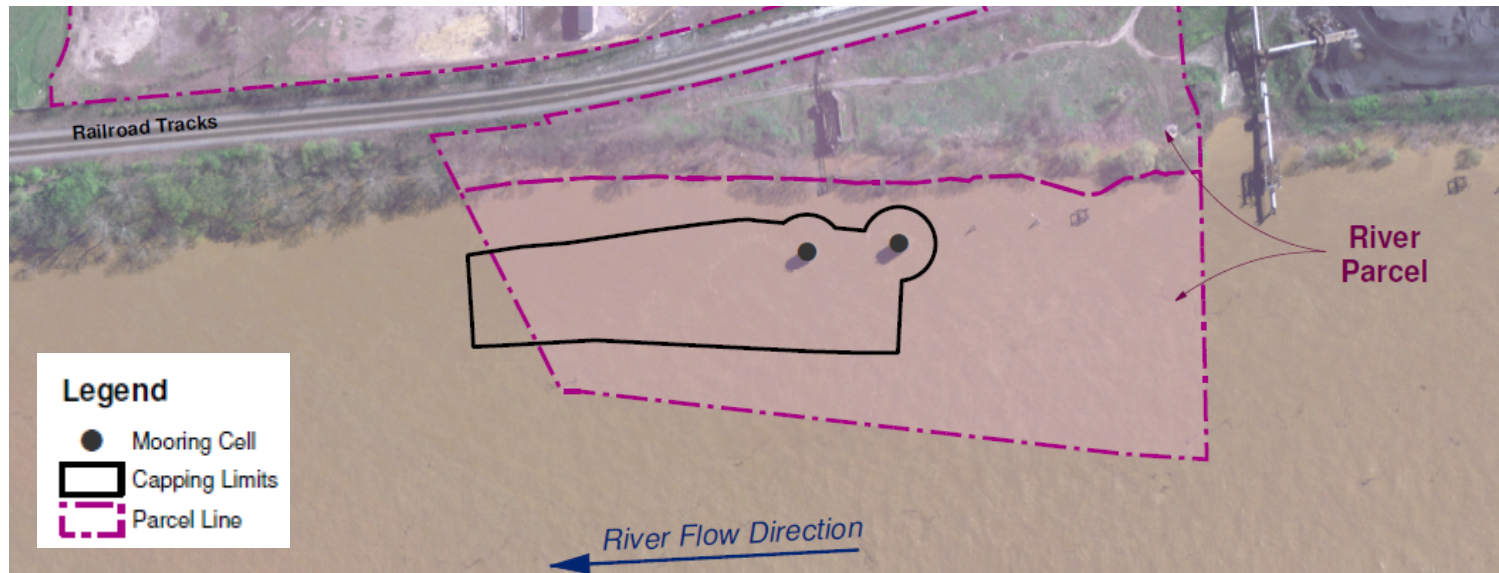
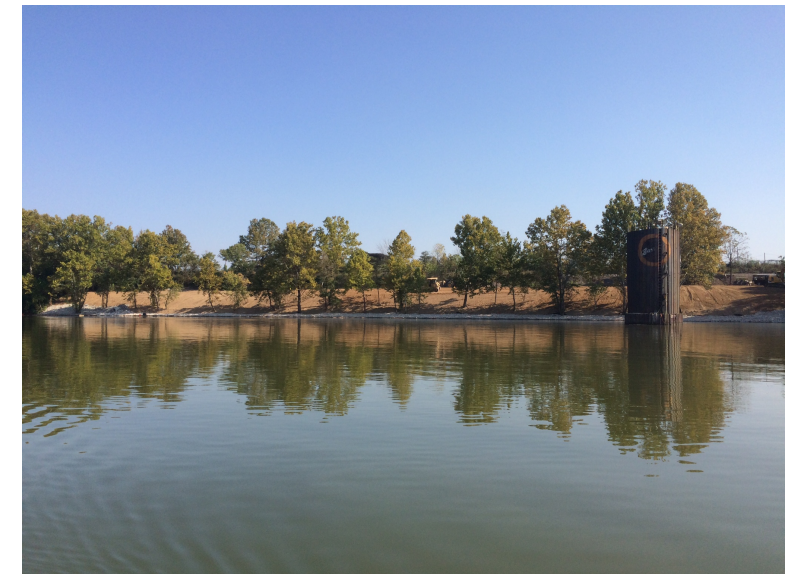
- Cap designed to isolate over 2 acres of PAH-contaminated sediments containing tar and NAPL in some areas
- Long-term cap monitoring has demonstrated effectiveness for more than 10 years

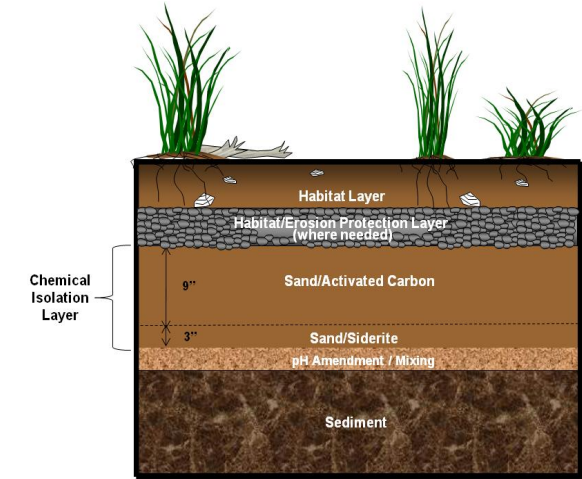
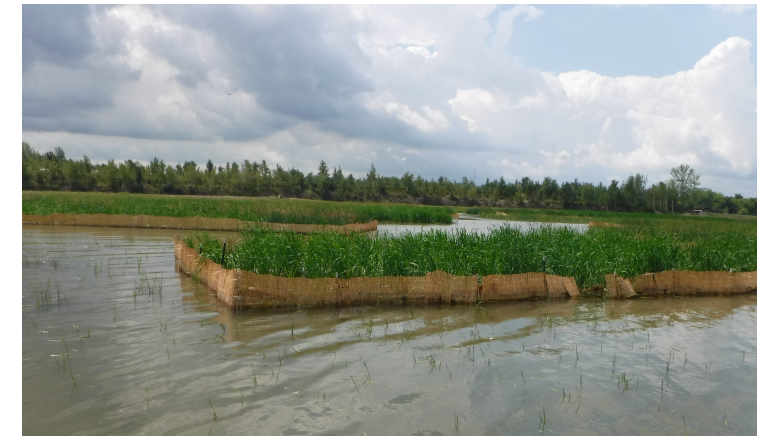
- A multi-layer, multi-function cap was placed over ~400 acres from 2012-2016
 - Design incorporated granular activated carbon to isolate contaminants and a siderite amendment for pH control
- During cap construction, a disturbance in the cap was identified due to very soft sediments at the bottom of the lake
- Design refinements were rapidly developed, and the cap was successfully reconstructed
- Long-term monitoring is ongoing, and the latest Five Year Review (2020) concludes that the cap remains physically stable and is functioning consistent with the design
- Caps included dedicated layers designed to support habitat restoration
